CNC Chucker Lathe Customer Notice

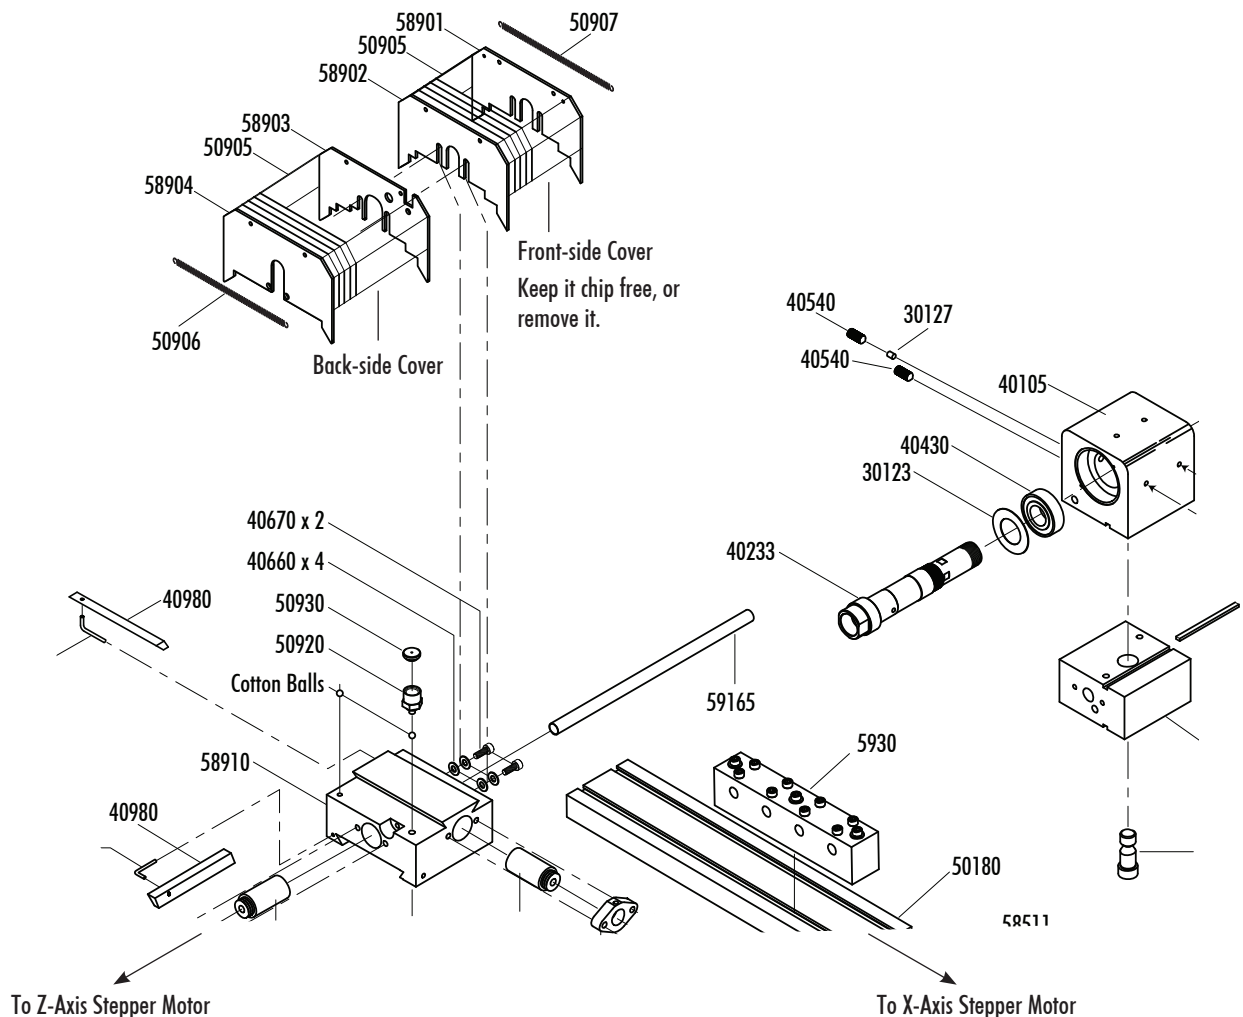
Your chucker lathe comes with an accordion way cover to protect the ball screw on both sides of the saddle.

What we have found is that neglect to brush away the chips on the cover (P/Ns 58901 and 58902) will cause a build up of chips below the spindle (P/N 40233). This will interfere with the Z-axis travel. In other words, you will turn your machine into a “chip compactor.” This excessive buildup of chips will impede the movement of the Z-axis to a point where the stepper motor will begin to stall and miss steps.

The accordion cover on the backside (P/Ns 58903 and 58904), closest to the stepper motor, is needed to keep chips off the ball screw. **DO NOT REMOVE IT!**

However, there is a brass cover tube (P/N 59165) over the ball screw on the headstock side. This tube makes it virtually impossible for chips to get onto the ball screw.

What we suggest is that either you brush the chips off the front accordion cover on a regular basis, or you remove the front cover entirely.
